Debris/Ice/TPS Assessment And Photographic Analysis For Shuttle Mission STS-31R

Charles G. Stevenson
NASA/Kennedy Space Center

DEBRIS/ICE/TPS ASSESSMENT
AND
PHOTOGRAPHIC ANALYSIS
OF
SHUTTLE MISSION STS-31R

April 24, 1990

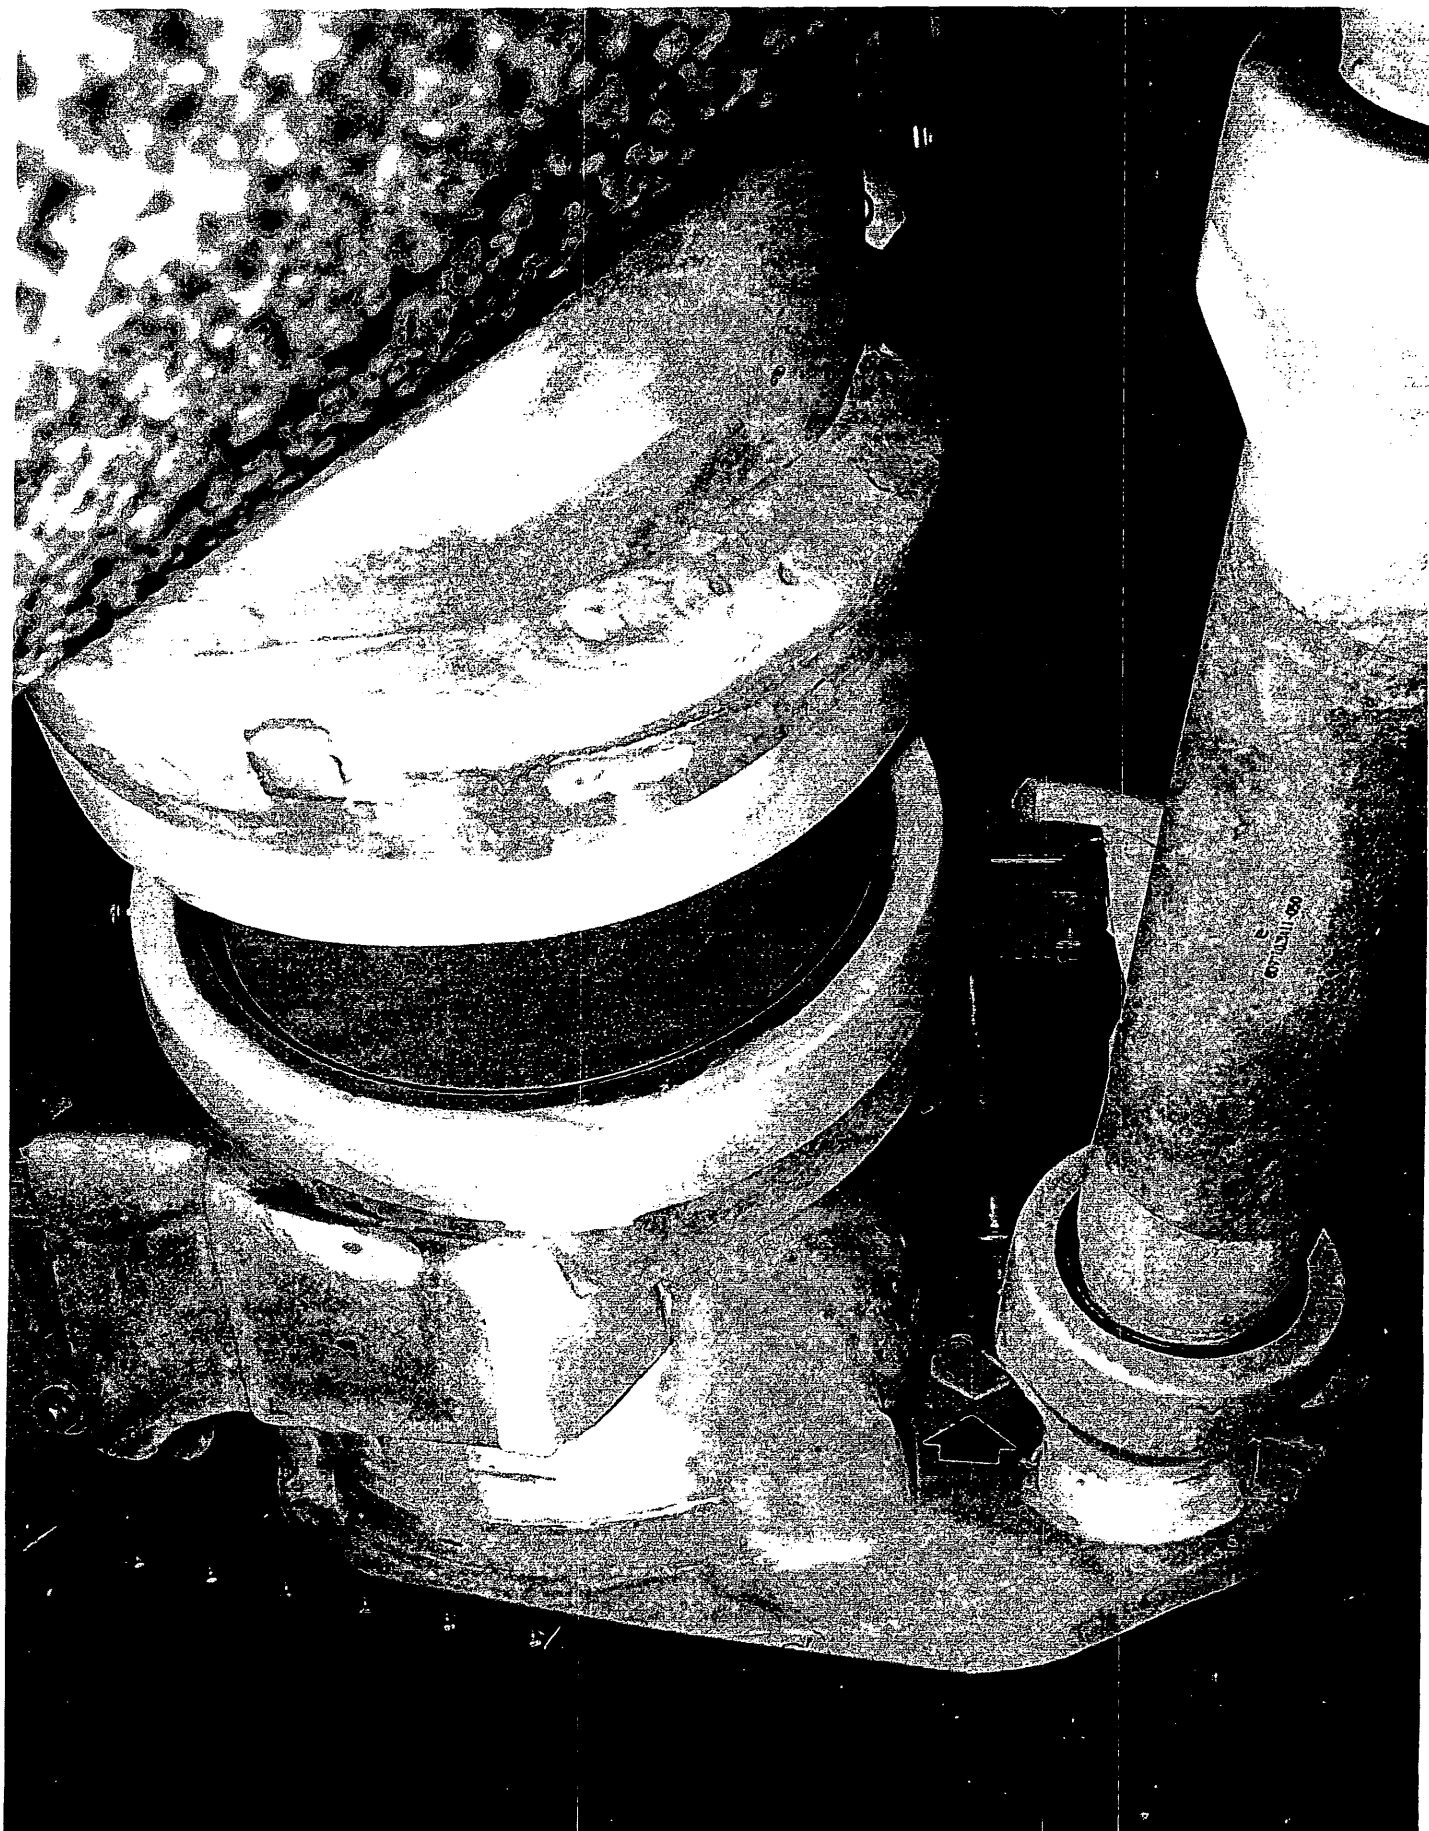
Overall view of LH2 ET/ORB umbilical. Note PDL foam plug in flapper valve actuator torque tool port closeout (arrow)

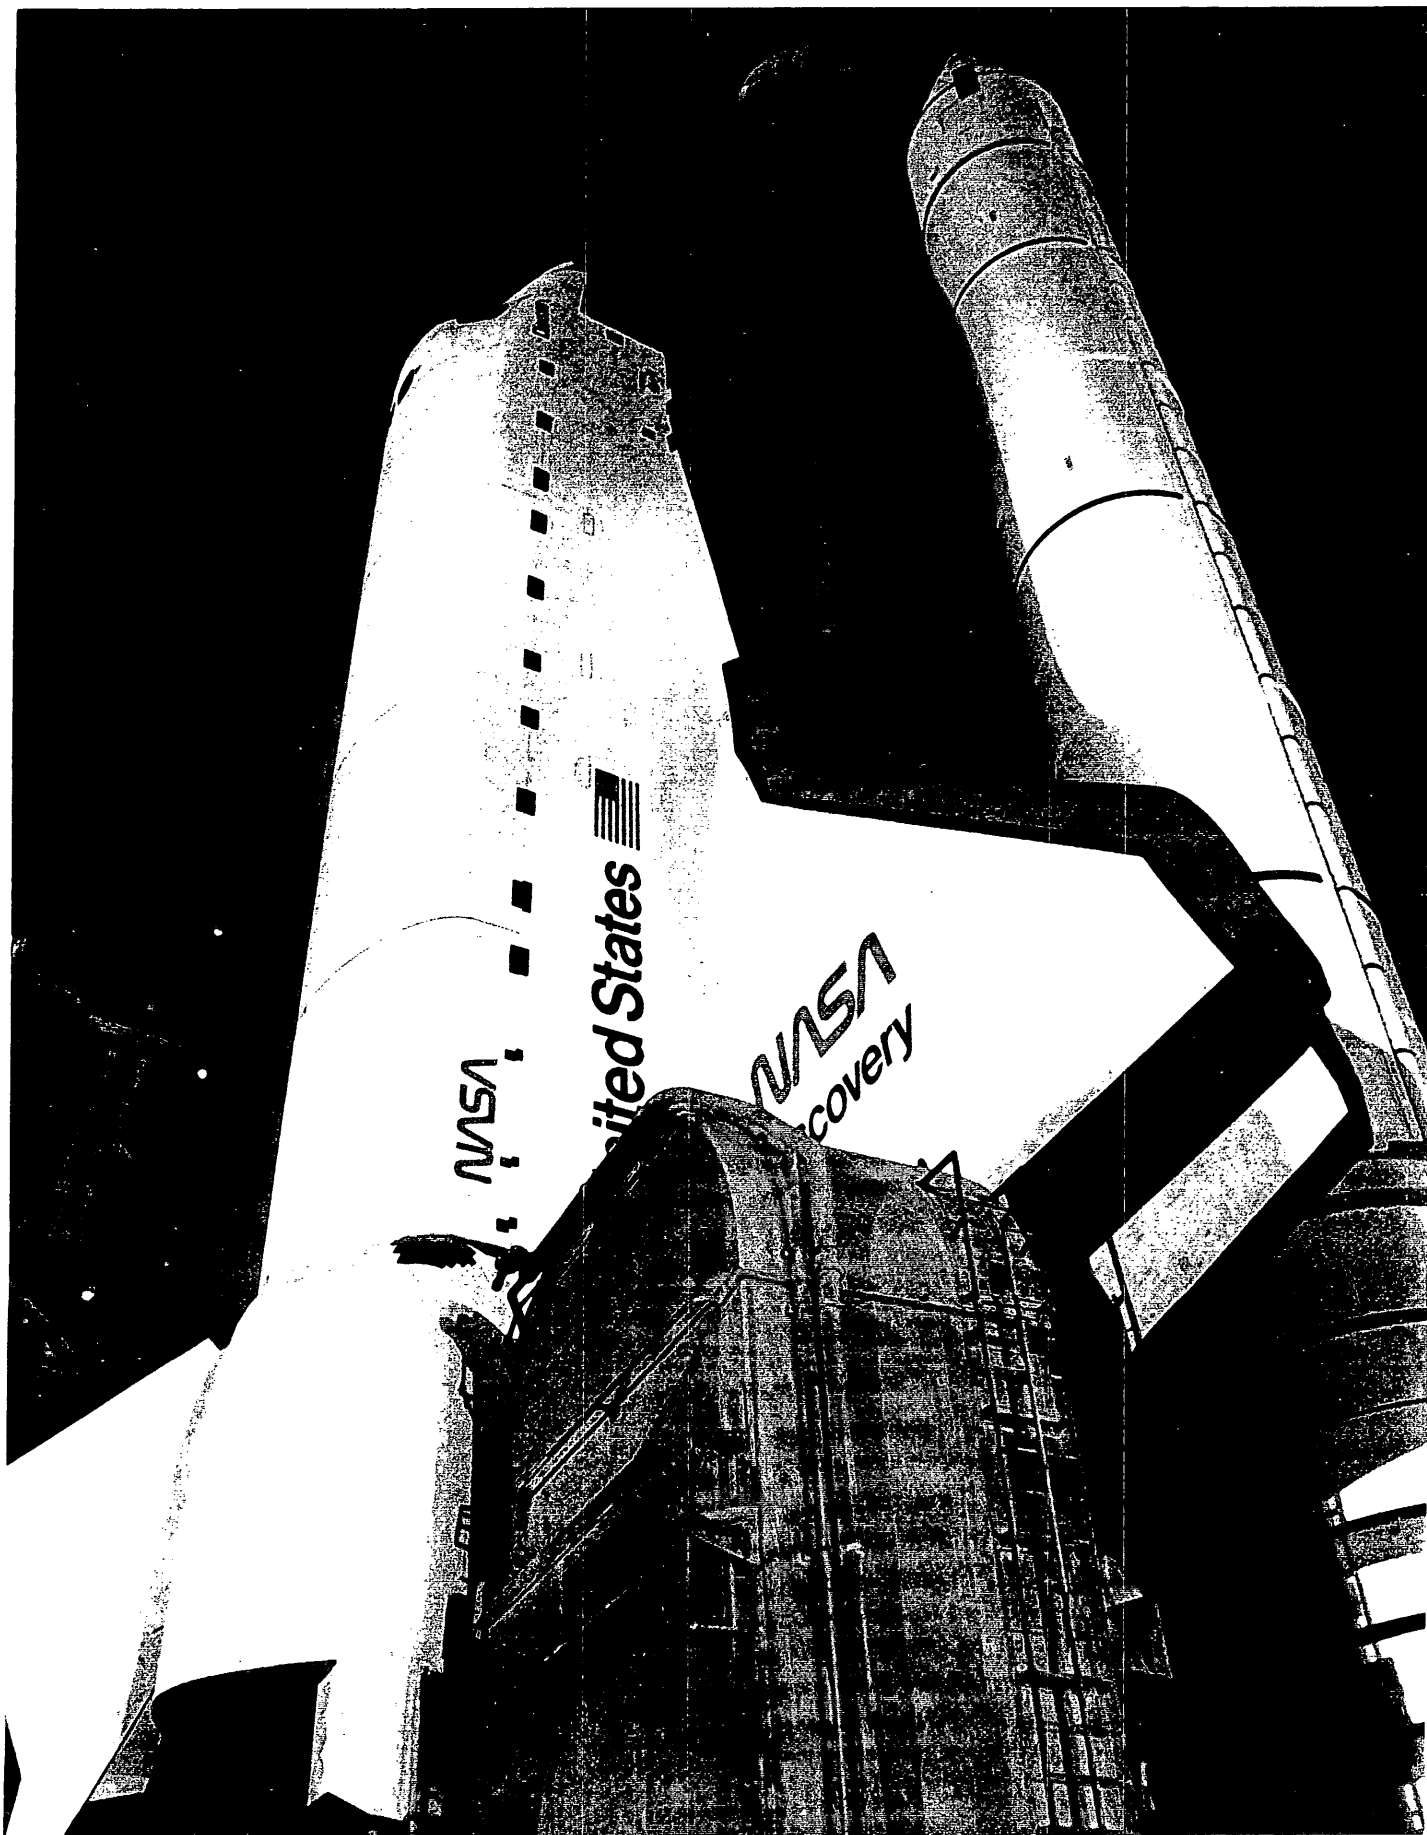
No ice/frost formed on the ET acreage +Y+Z side

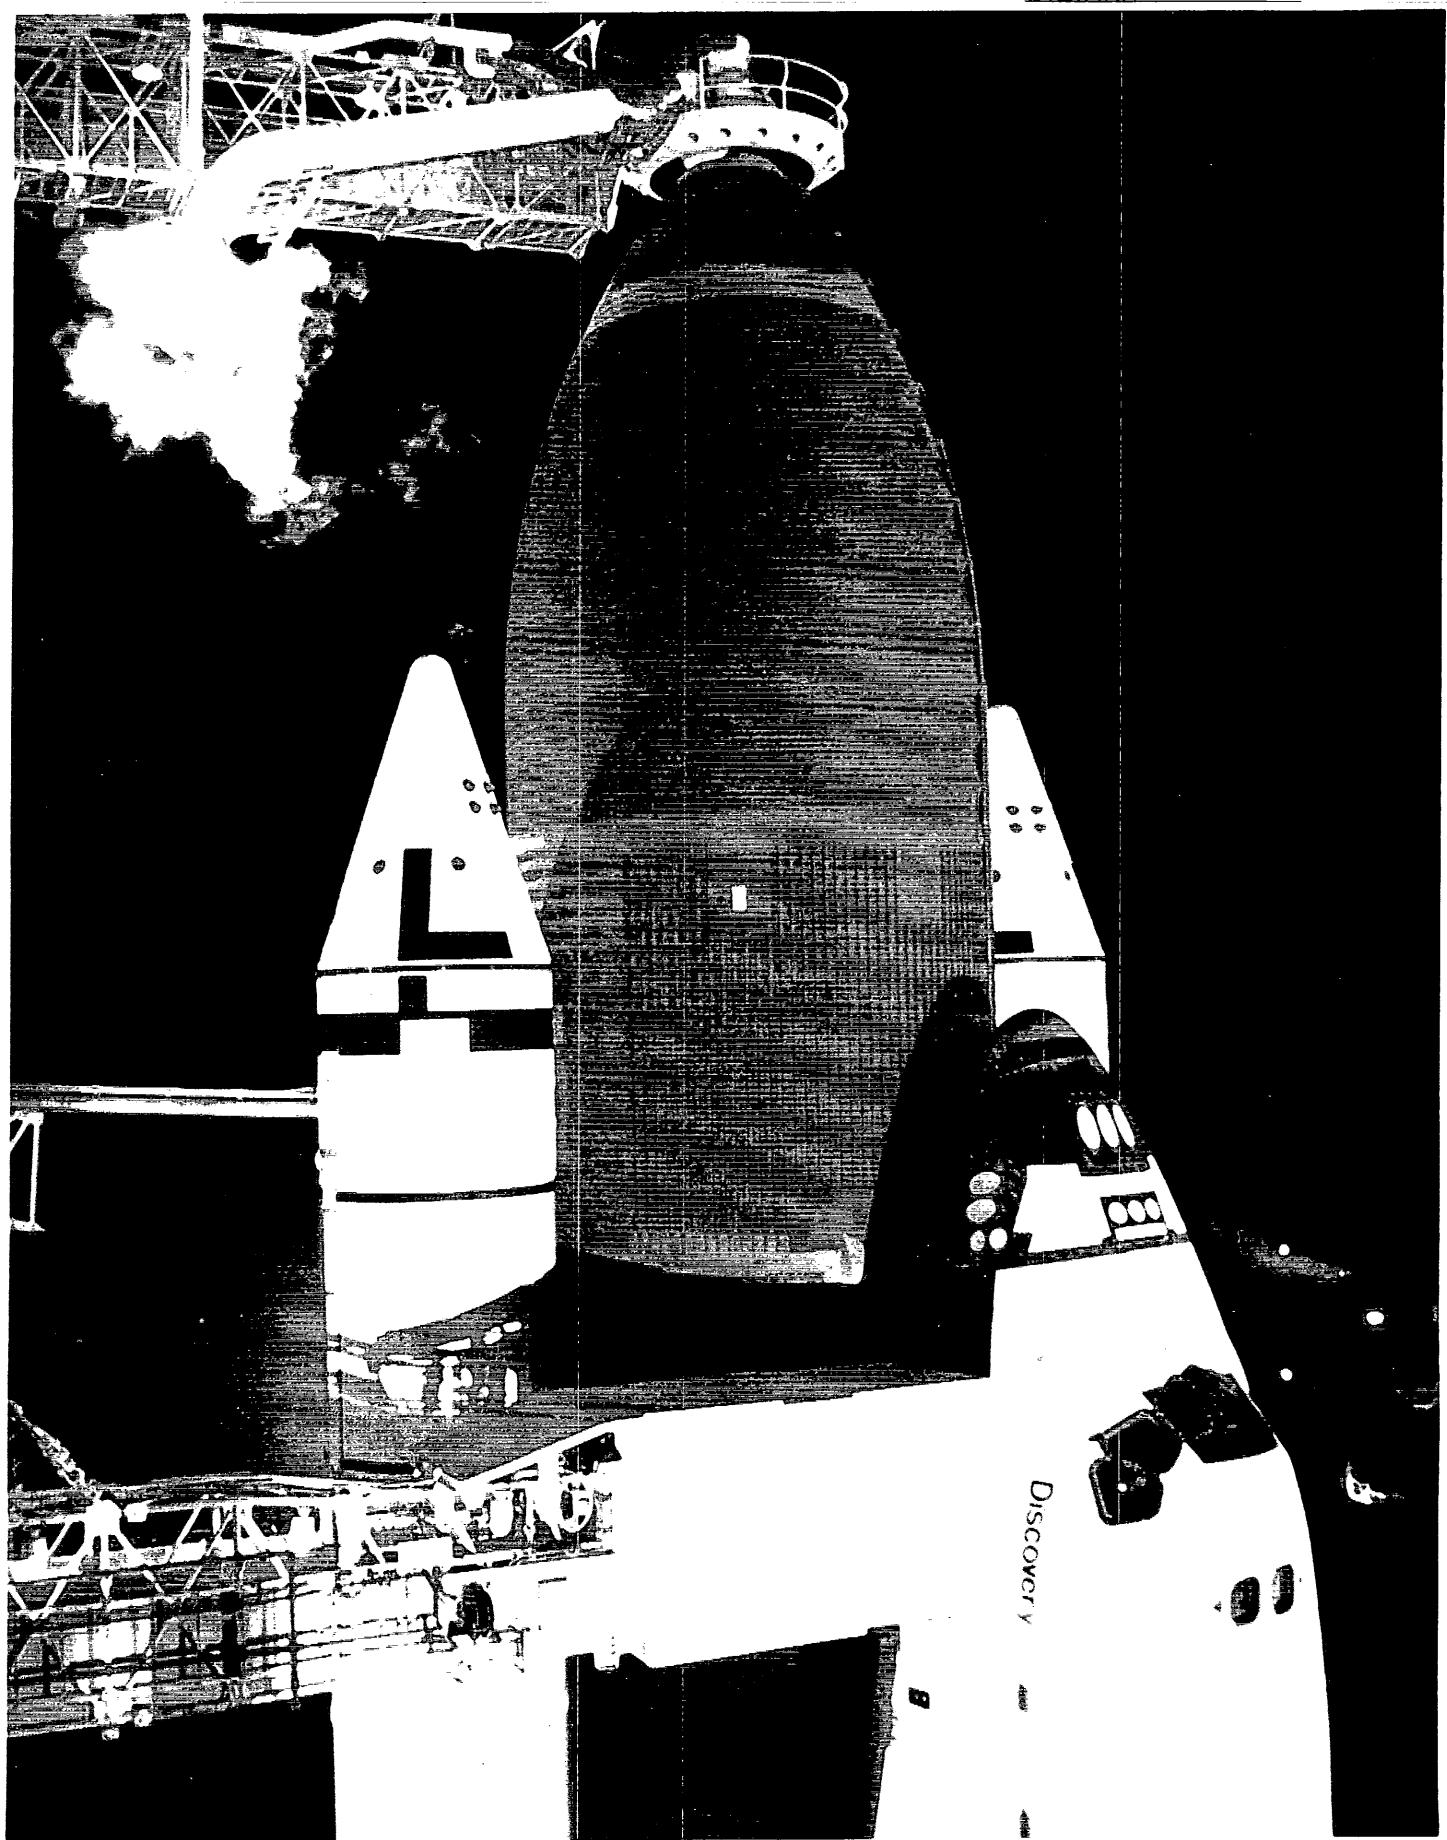
No acreage ice/frost was present on the L02 tank acreage
ogive and barrel section

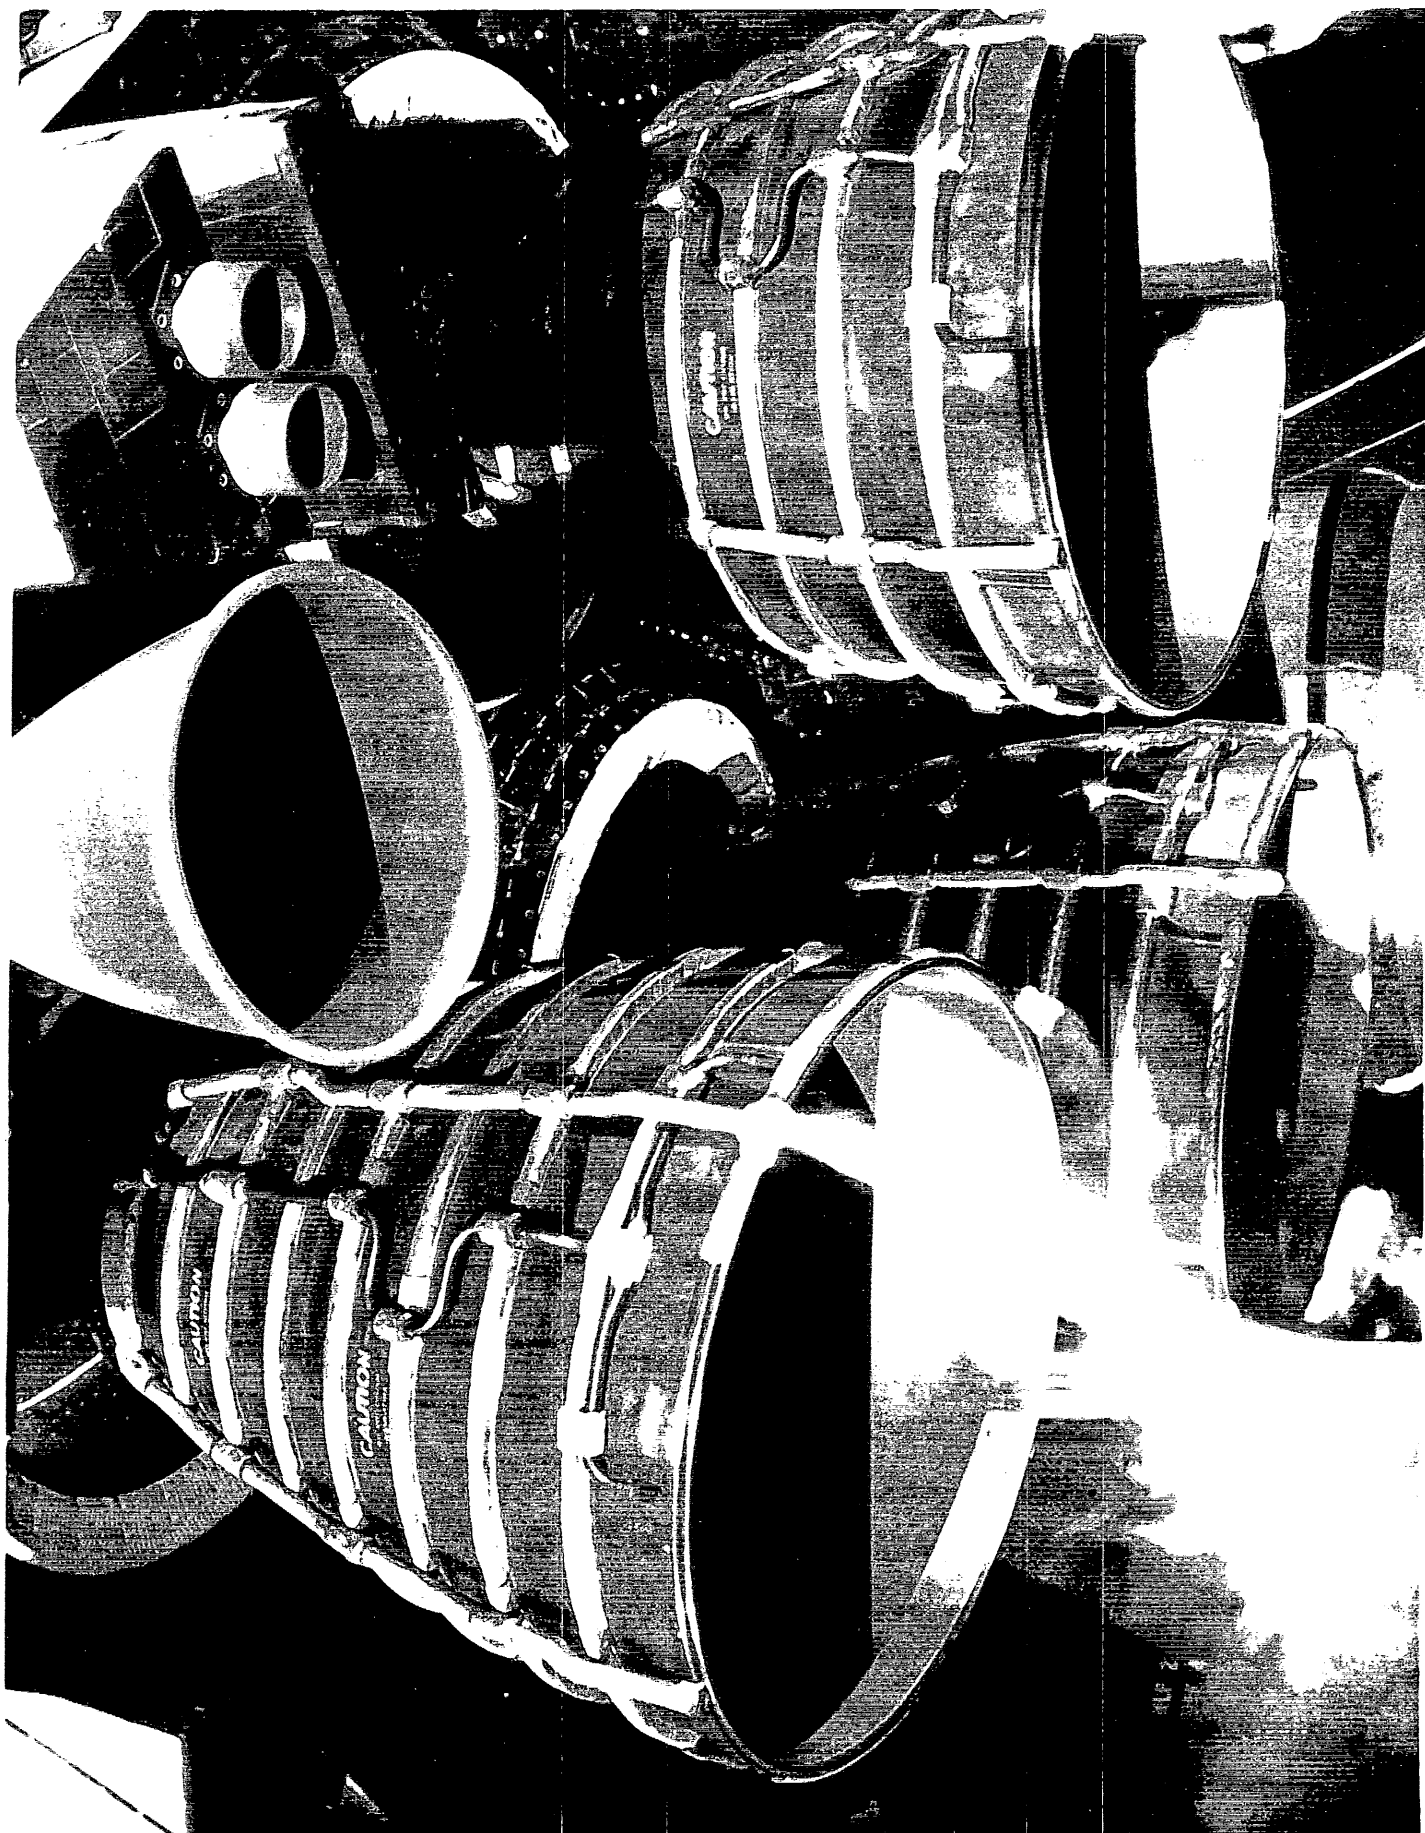
Less than usual amount of ice/frost formed at the main engine
to heat shield interfaces

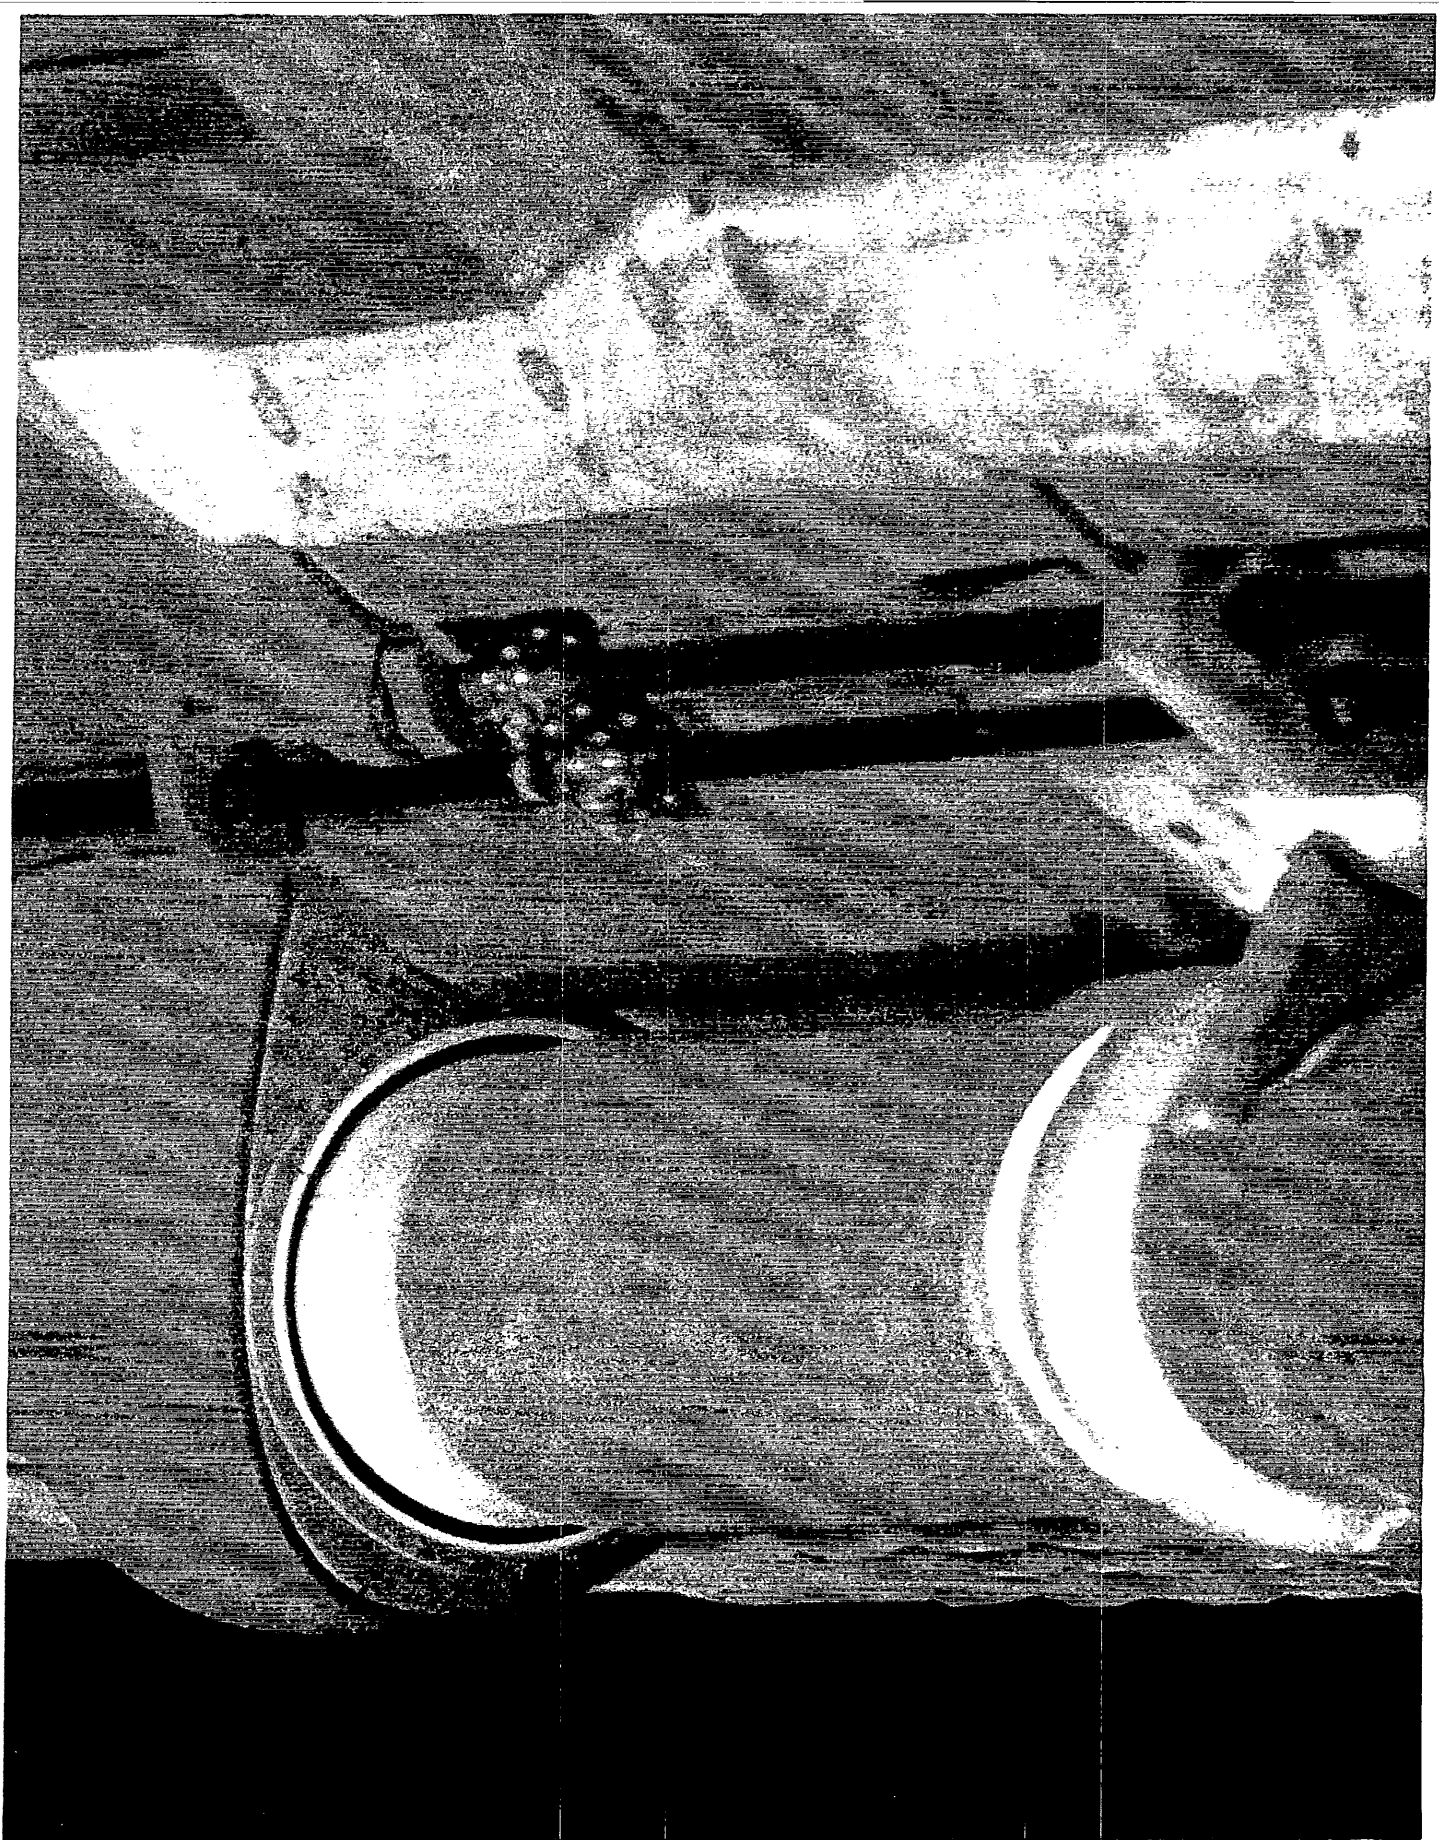
Typical amounts of ice/frost accumulated in the L02 feedline
support bracket and upper bellows

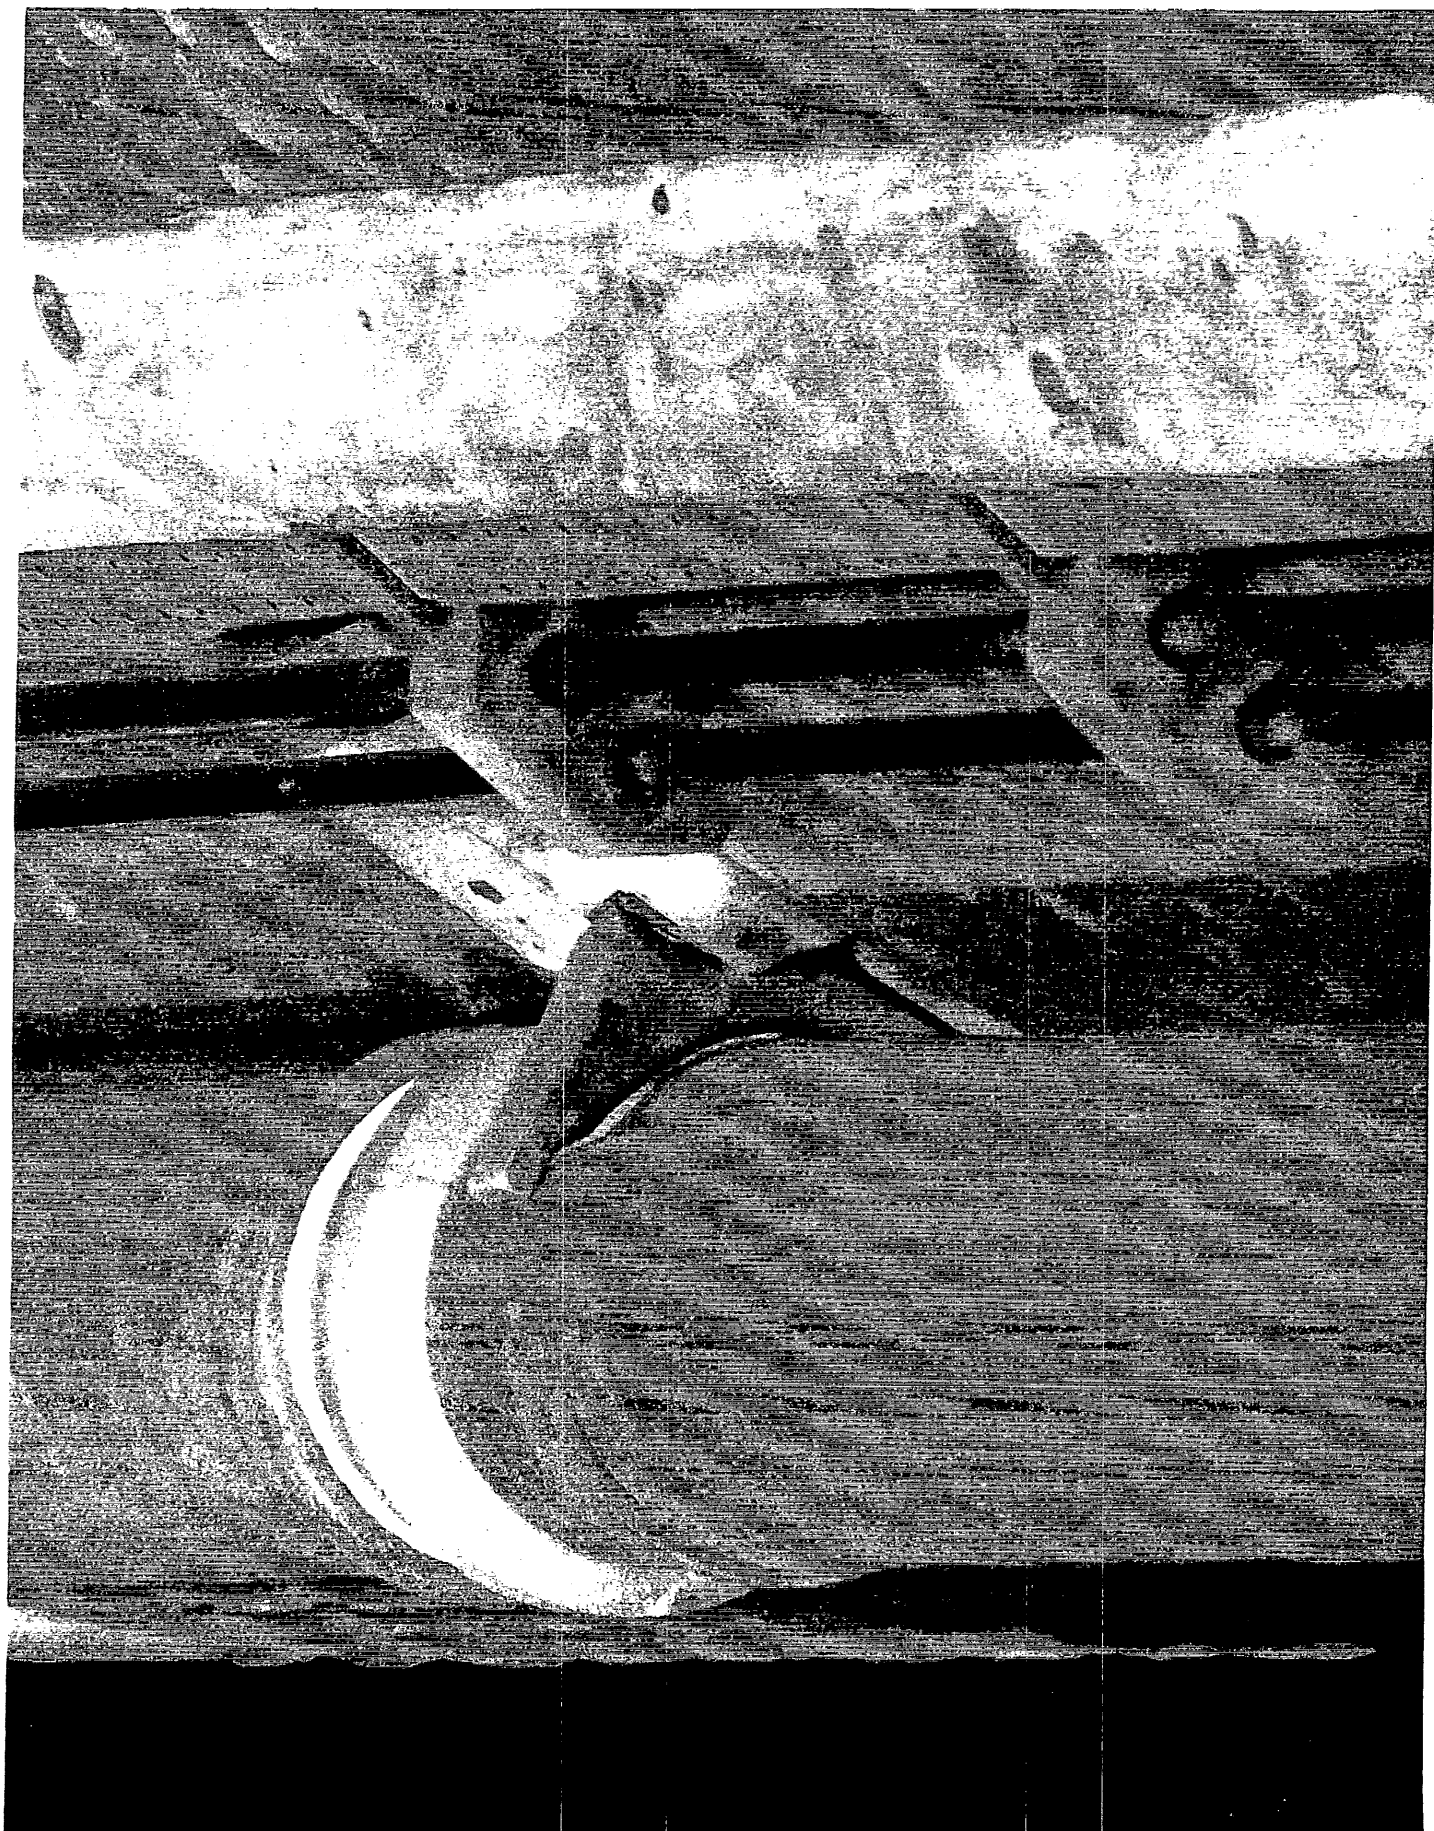
Typical amounts of ice/frost had formed in the LO2 feedline
support brackets and bellows

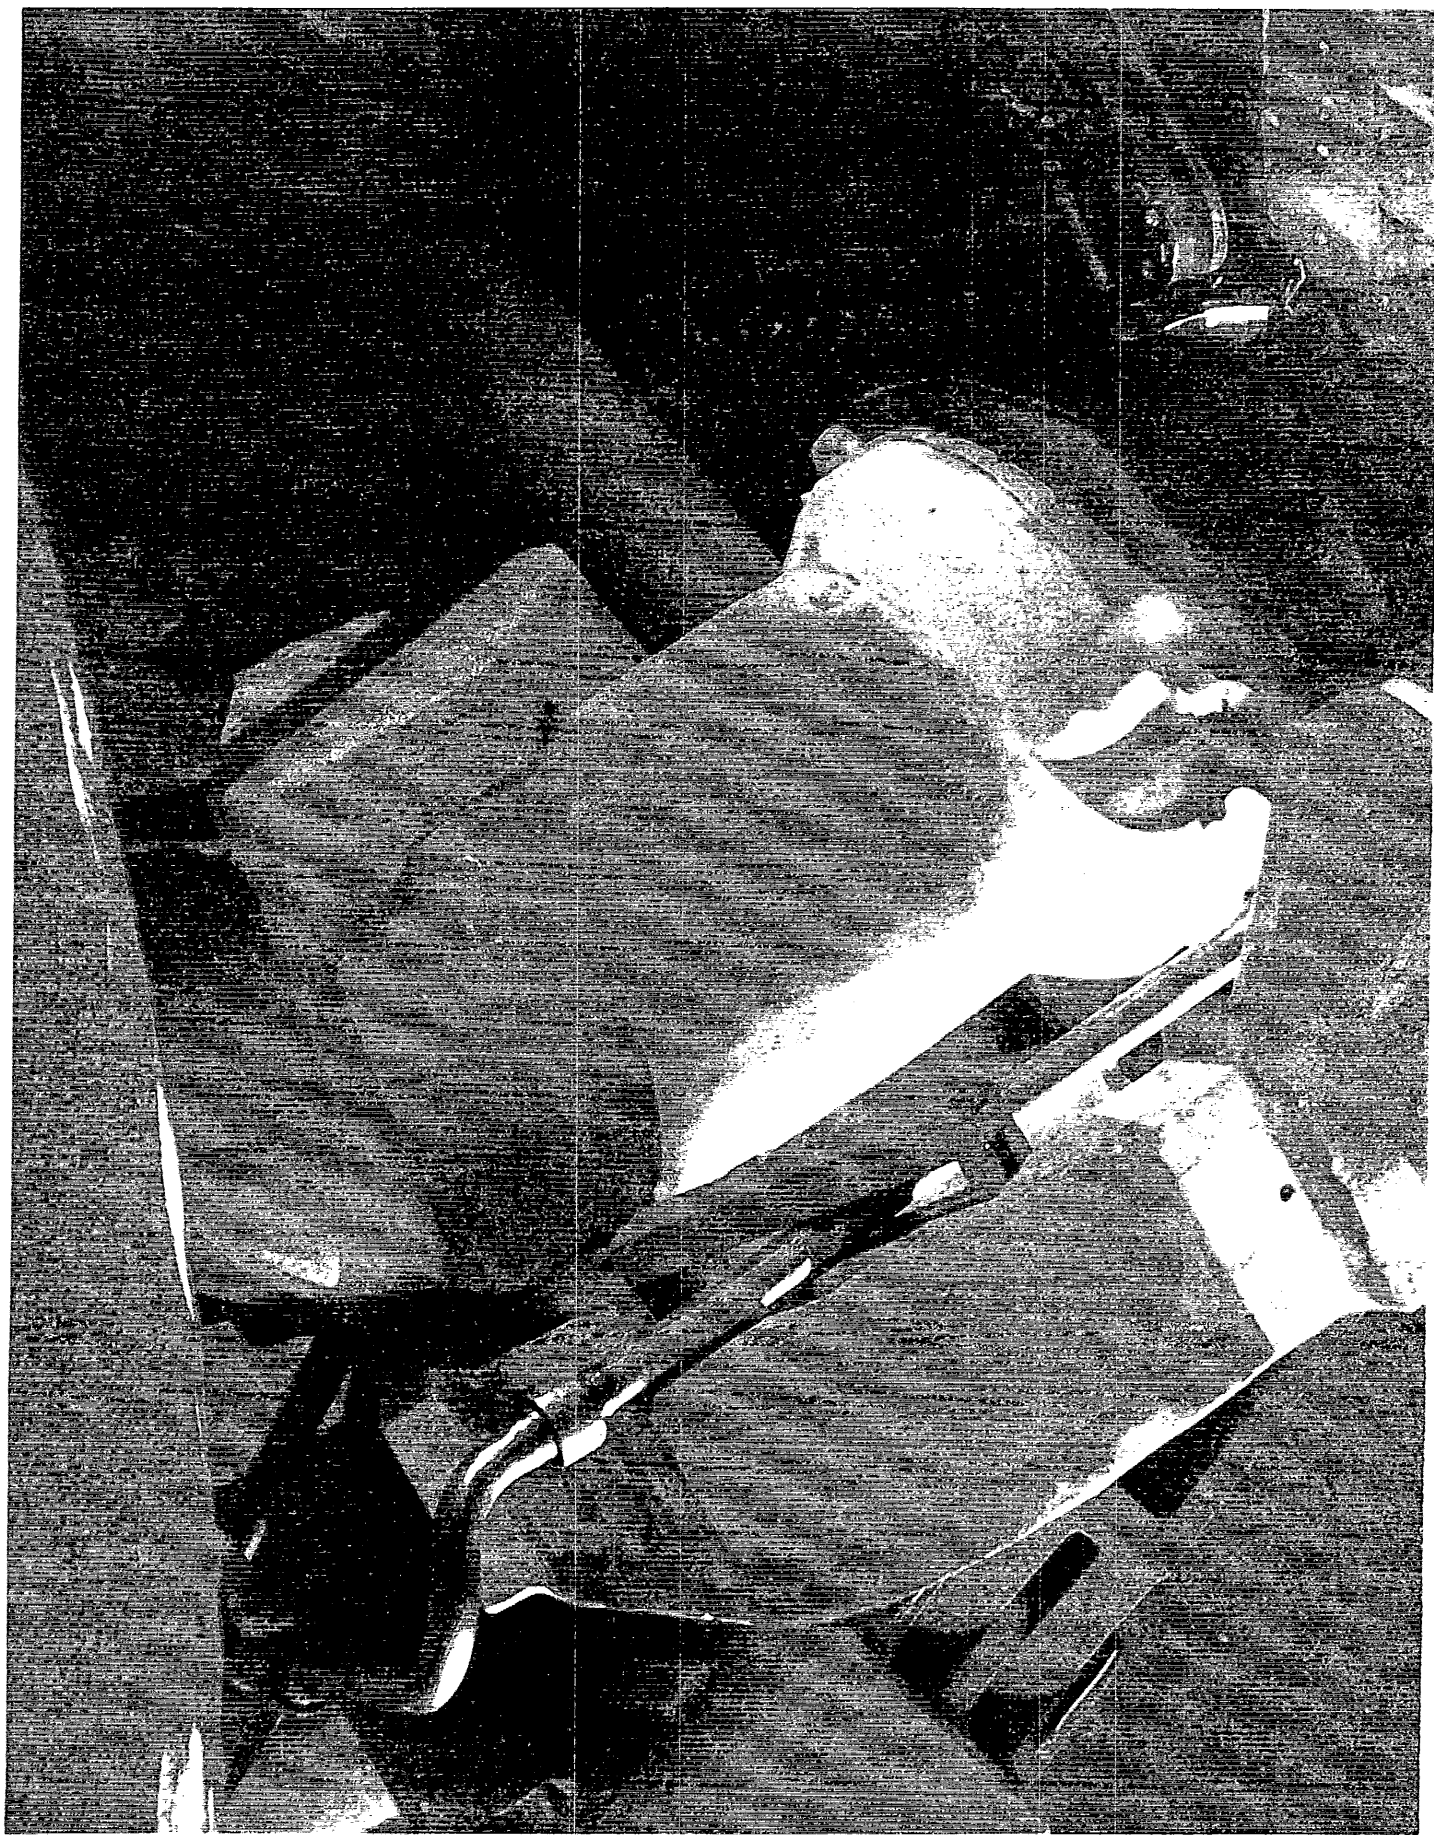
Ice/frost accumulation on the LO2 ET/ORB umbilical occurred
on the aft and inboard sides, and on the purge vents

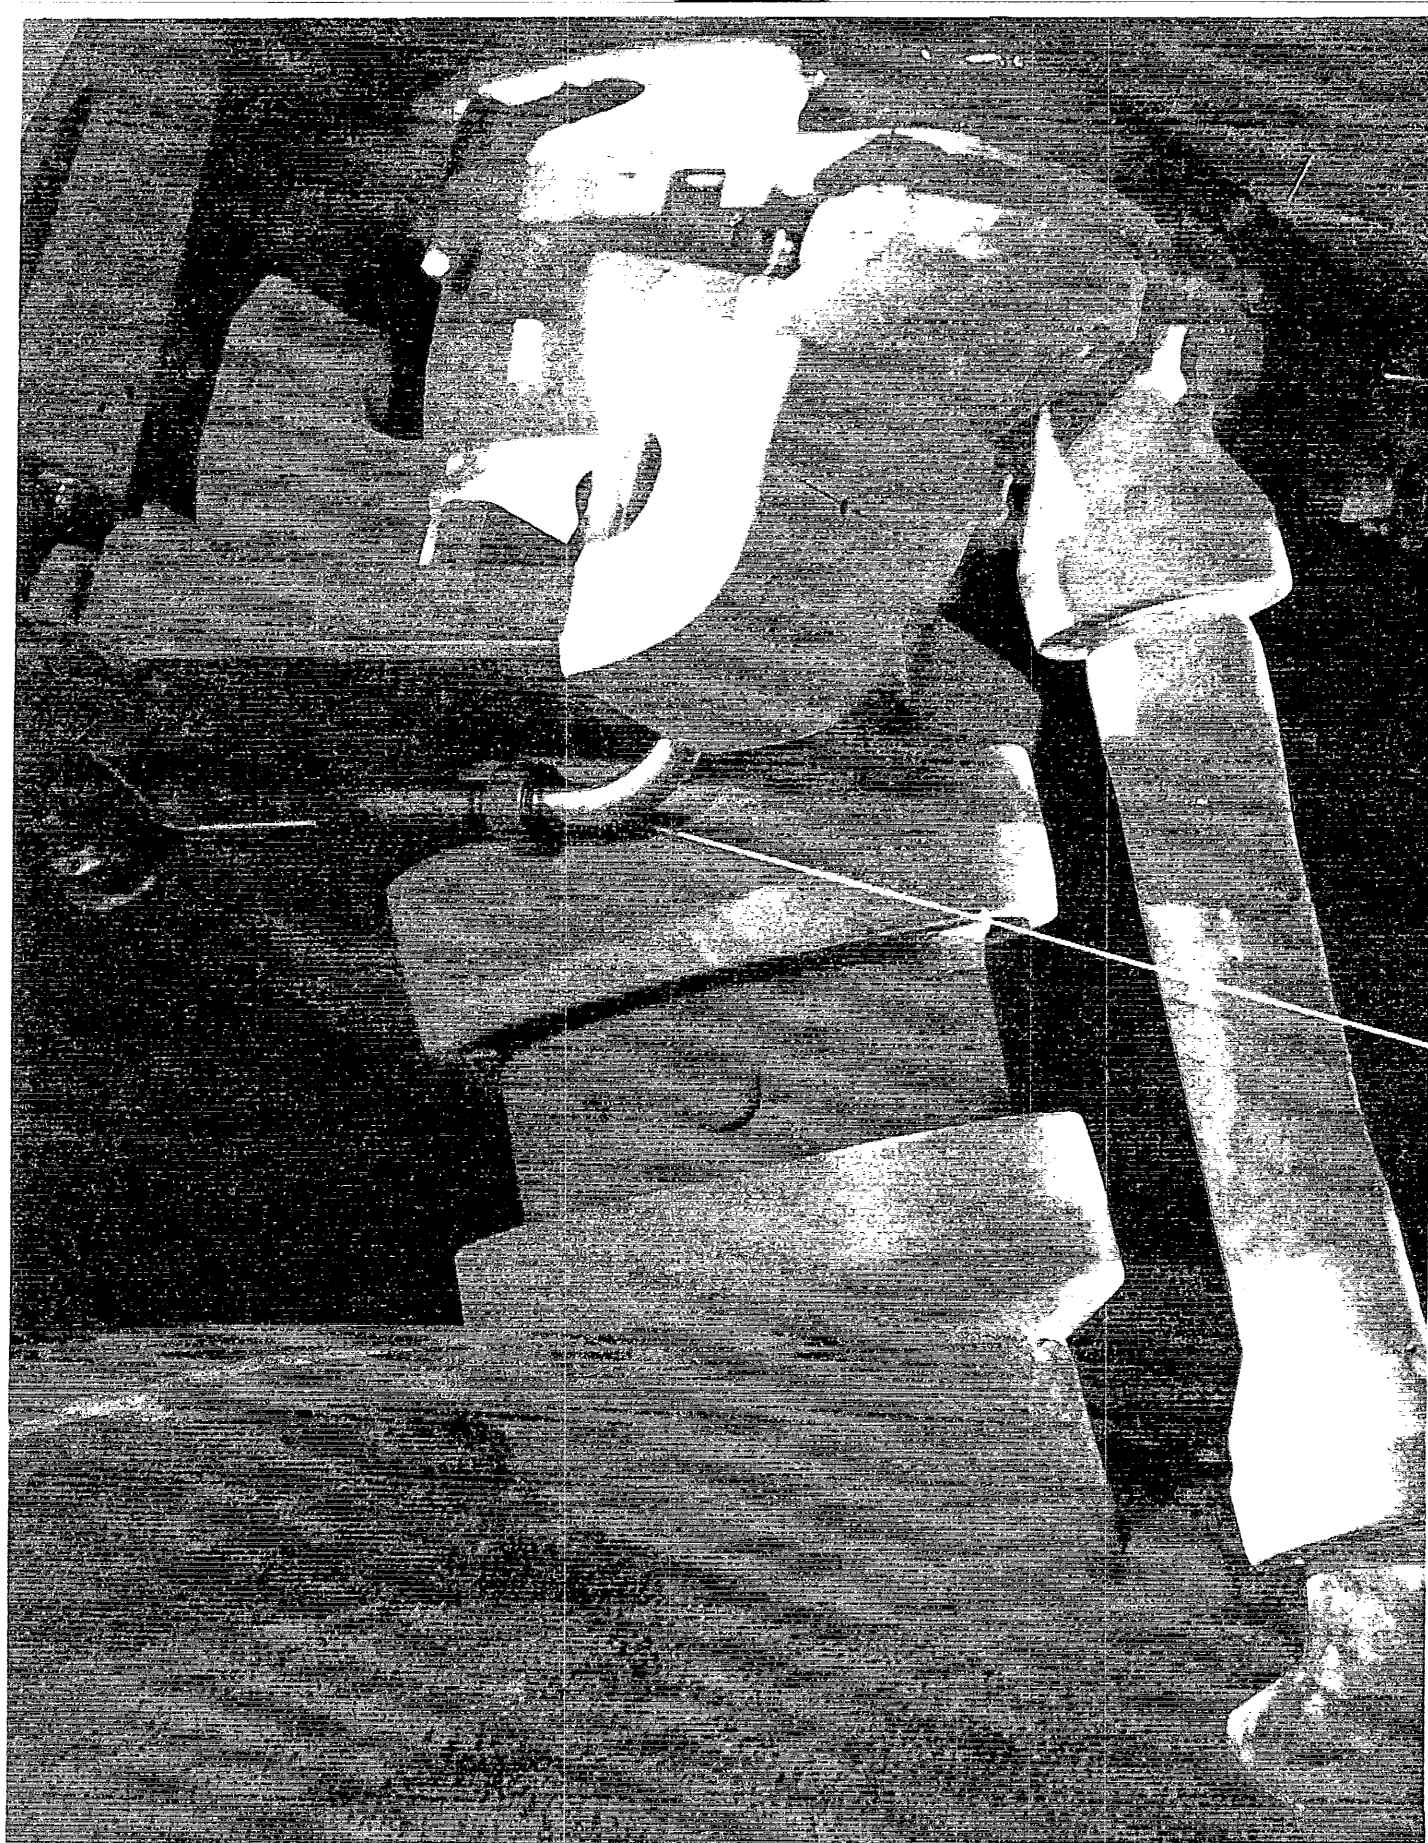
Ice/frost accumulation on the top and outboard sides of the LH2 umbilical was typical. Note frost fingers on purge vents.
